### **BACKGROUND:**

At a construction site in Perth a scissor lift operator has driven his machine over a penetration which was covered with formwork ply.

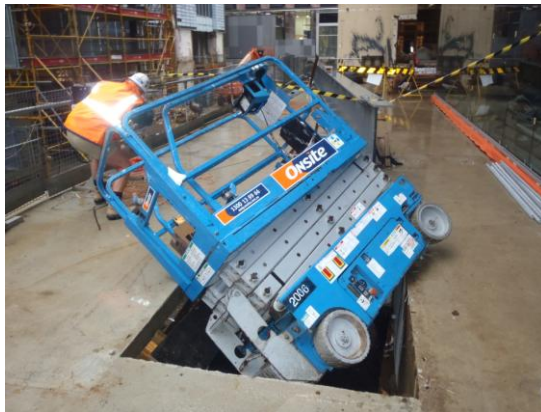
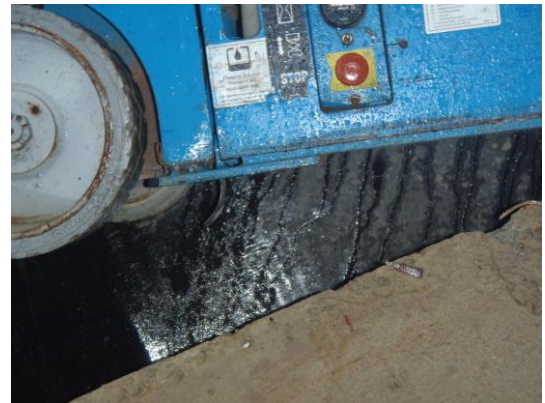
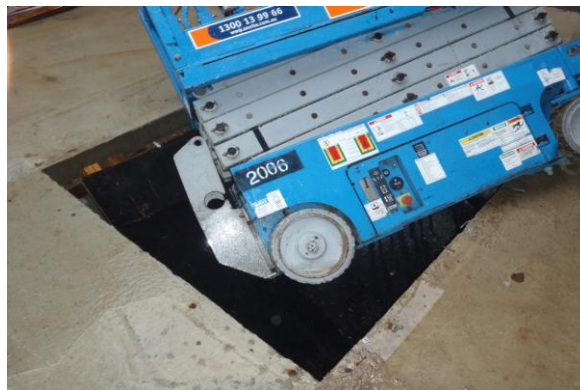
The combined weight of the EWP and operator has caused the ply to fail causing the machine to fall into the penetration. The operator has managed to jump from the machine and did not sustain any injuries.

Upon inspection of the incident site it was noted that the penetration cover was not properly marked "DANGER-HOLE BENEATH" or was there any physical barrier in place to prevent any mobile plant from driving over the penetration cover.

The construction of the cover was not of adequate strength to allow any plant or equipment from travelling over it.

The estimated weight of the machine was 1500kg.

- Ensure that all penetrations are covered and securely fixed
- Any covering used is clearly and legibly marked "DANGER-HOLE BENEATH"
- Any material used as a cover is strong enough to prevent persons or things from falling into the penetration or to put in place a physical barrier in areas where mobile plant may be present.
