**BACKGROUND:**

A crane, while operating at a domestic construction site, has tipped over with the boom of the crane coming in contact with the house under construction and a neighbouring property. The main sheave has landed in the pool area of the adjoining property. No one was injured.

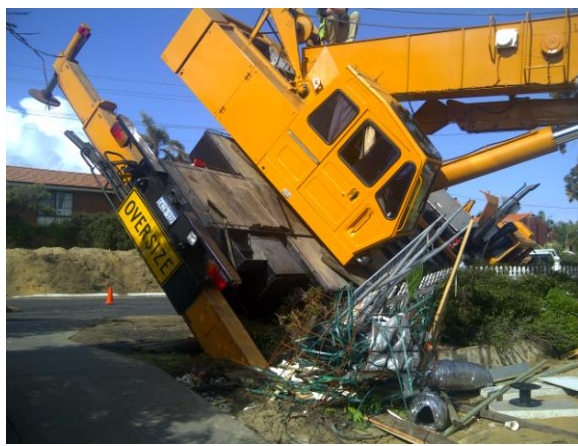
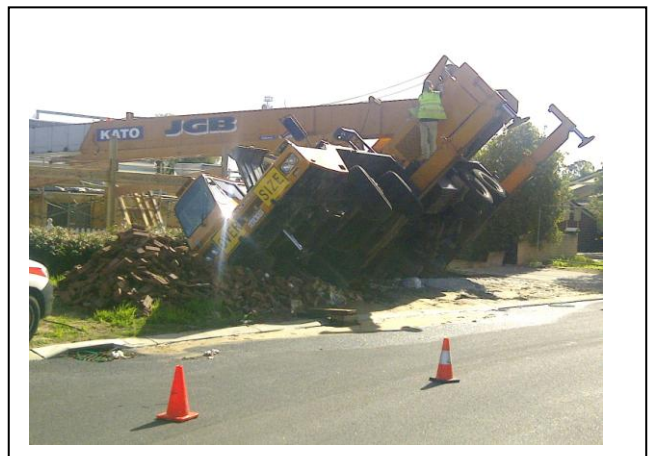
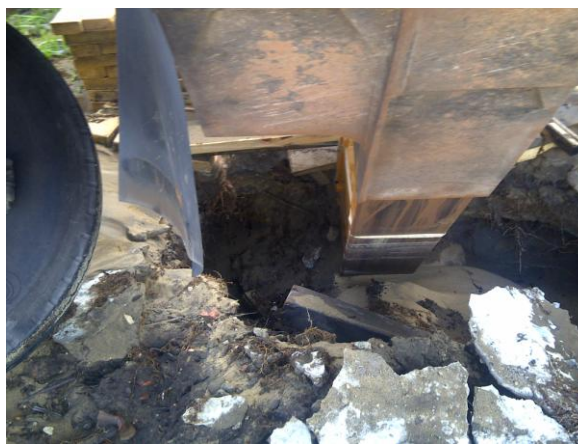
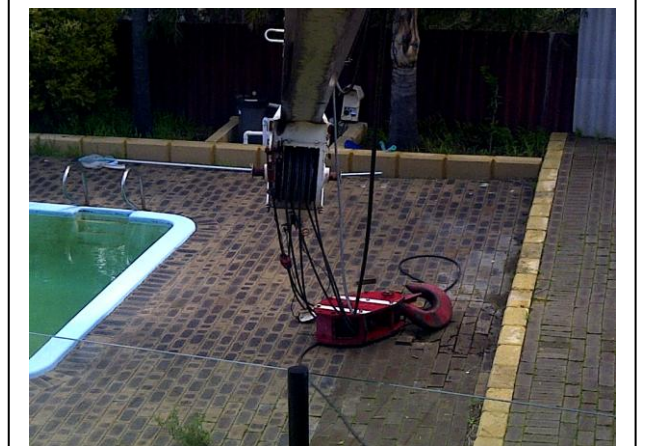
The main cause of the incident appears to be the failure of a water mains supply pipe which was located in the front verge area of the property.

One of the cranes outriggers was above the pipe when it failed. Subsequently the soil was washed out from underneath the outrigger which led to the crane becoming unbalanced and tipping over.

- The location of underground services should always be taken into consideration when setting up a crane.
- Ground type and ground conditions should be included in all pre lift risk assessments.
- Always ensure adequate exclusion zones, where practicable, in any areas where cranes are in operation.
