Grinder Incidents

Another angle grinder incident at a project in east Perth has highlighted the need to assess any works involving grinders to ascertain safer work methods.

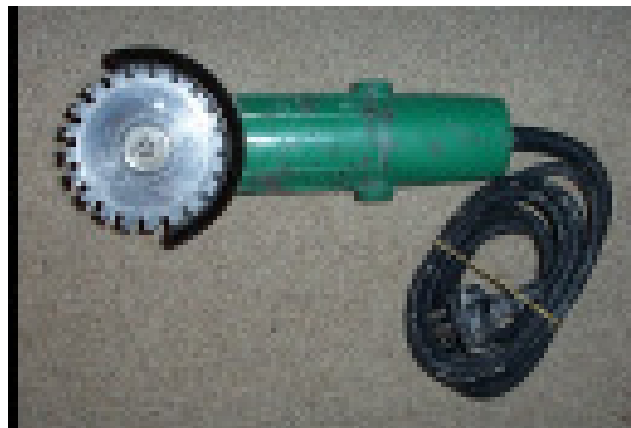
Multi-cutters or tungsten tip blades pictured below are becoming more commonly used on angle grinders. The blades are not marked with safe rotational speeds or manufacturers instructions on the safe use of those blades and **MUST NOT BE USED.**

Saw blades in angle grinders must not be used

- ◆ Employers must provide supervision instruction training and PPE
- ◆ Manufacturers instructions must be adhered to for the safe use of, selection and maintenance of power tools and abrasive wheels. Operating speeds should not be exceeded.
- ◆ Exclusion zones or safe work areas should be established to prevent injury or harm to other persons in the vicinity.
- ◆ Personnel protective equipment must be used including double eye protection, hearing protection, suitable clothing i.e. tight fitting clothing to prevent entanglement.
- ◆ Before grinding works begin your employer in conjunction with workers must assess the risks associated with the use of grinders, apply the hierarchy of controls principles and implement controls. Where possible elimination is the preferred option.
