BACKGROUND:

A contractor has fallen from a mobile scaffold in the process of climbing down from the working deck.

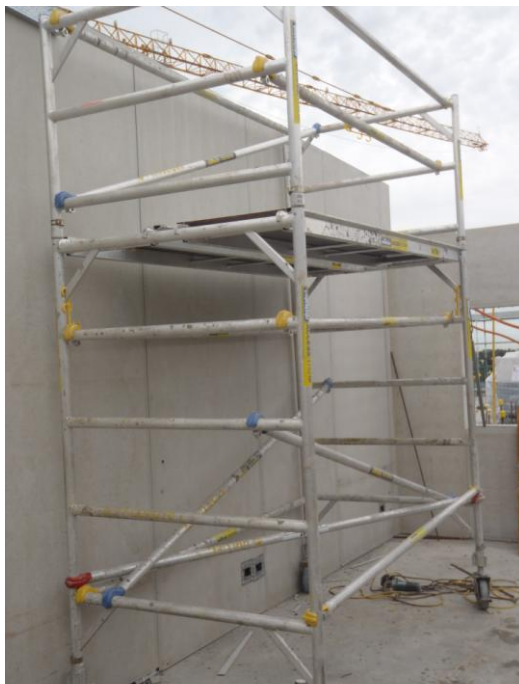
Scaffold not erected in accordance with Australian Standards

- No ladder access
- No kickboards
- Insufficient handrails

- All scaffolds on site are erected to meet Australian Standard(AS1576 parts 1-6)
- Persons erecting scaffold have undergone the appropriate level of training.
- All mobile scaffold kits that are brought onto site have the required number of components to ensure they meet Australian Standards e.g. sufficient number of ledgers to provide a top and mid rail for edge protection and kickboards, if working deck is to be 2 meters and above.
- Erection guides to be provided along with all mobile scaffold kits.
- Any scaffold that does not meet the required standard is not to be used

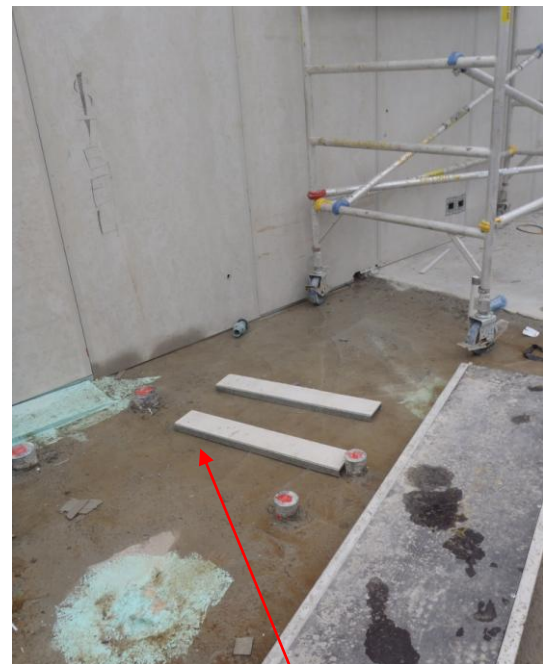
Area where the worker landed narrowly missing pipe work
