**BACKGROUND:**

The edge lifting lifting anchors located on a tilt up panel have failed during the erection process. A crane was lifting the panel into position when the one of the lifting anchors has pulled out, this left the entire weight of the panel on one anchor which has also failed, and this resulted in the top section of the anchor being torn off completely. No one was injured but riggers had to take evasive action to prevent from being struck by the falling panel

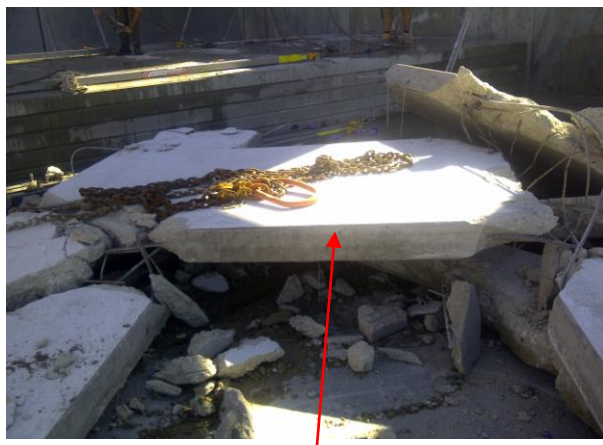
It would appear that the hairpin lifting anchor, which has pulled out, was not properly installed into the panel as per the design. This has left the anchor with no structural integrity what so ever, which subsequently resulted in its failure.

Resulting damage to panel after incident

- Ensure that all panels have been inspected and signed off as per the requirements of the National Code of Practice for Precast, Tilt up and Concrete Elements in Building Construction.
- Maintain a safe exclusion zone when concrete panel work is taking place.
- Verify that any lifting inserts/pins/anchors used in the panel manufacturing process meets AS 3850
- Ensure that all personnel involved in the transportation, manufacturing and erection of concrete panels have undergone the required training.

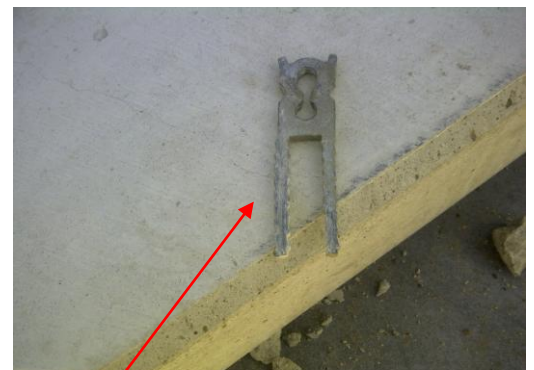
Hairpin anchor pulled completely out of the panel structure.

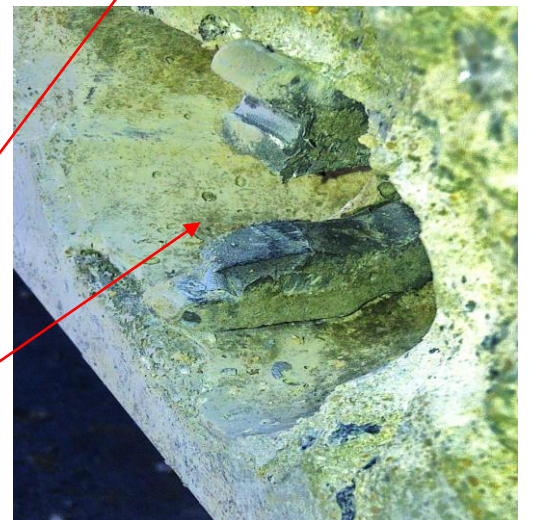
Second anchor with top section sheared off.
