August 2009

Failure of Prefabricated stair unit

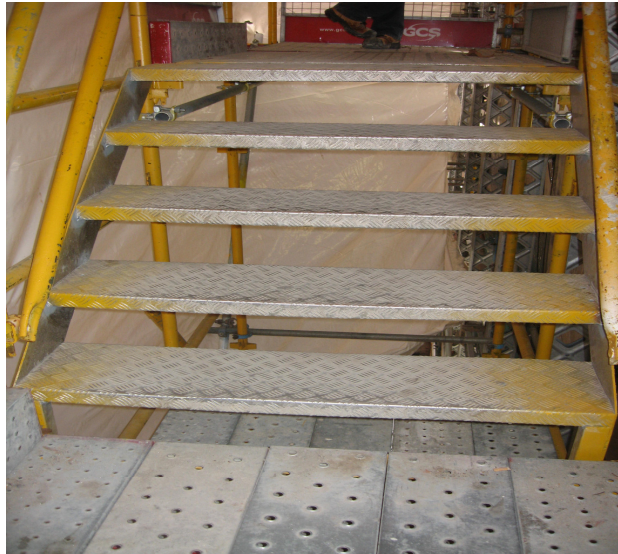
Worksafe WA is currently investigating a dangerous occurrence involving the failure of a prefabricated aluminium stair unit. The failure has allowed enough movement in a prefabricated stair unit to become dislodged from the supporting transom resulting person falling approx 10 meters to the ground below. *Inspections on various other sites found prefabricated aluminium stair units with similar issues.*

Prefabricated aluminium stair unit

- Ensure that any prefabricated stair units in use are physically secured by use of a tool.
- Businesses that hire out aluminium stair units ensure that each unit is inspected for defects between each hiring to ensure no unsafe units are supplied for use.
- Check to ensure that there are no bent treads, bent stringers, broken or bent pins, broken welds and assembly is not twisted.
- Scaffolders have important responsibilities to visually inspect scaffolding equipment for faults prior to installation.
- Rejected scaffolding components should be recorded, isolated and clearly marked to prevent reuse.
