Construction, Forestry, Mining and Energy Union

Recent Incident - Nylon Sling Failure

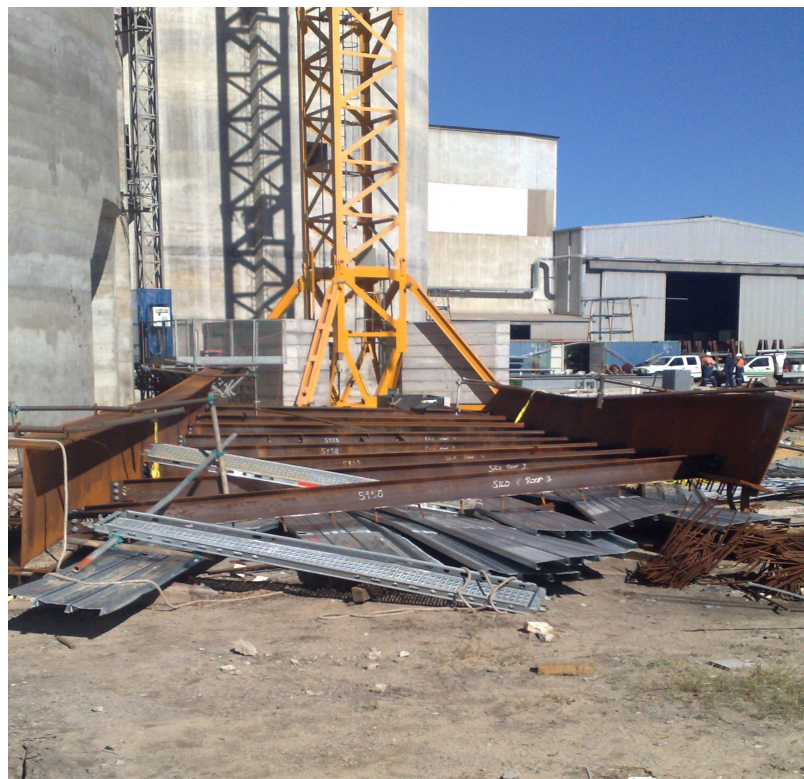
In summary a structural steel and bondeck roof section complete with handrails weighting approx 11 tonne was being lifted by site tower crane to be positioned on top of a silo. During the lifting of the roof section the nylon slings failed causing the load to fall to the ground. Fortunately no one was injured or killed.

- The number one cause of nylon sling failure is caused by load edge movement against sling. Always use packing to prevent slings coming into contact with sharp edges.
- A nylon sling will lose more than 10% of its strength when it is wet.
- They must be inspected before each use, send slings for a proof load test at least every 12 months.
- Never use if label has been removed
