BACKGROUND:

SAFETY ALERT

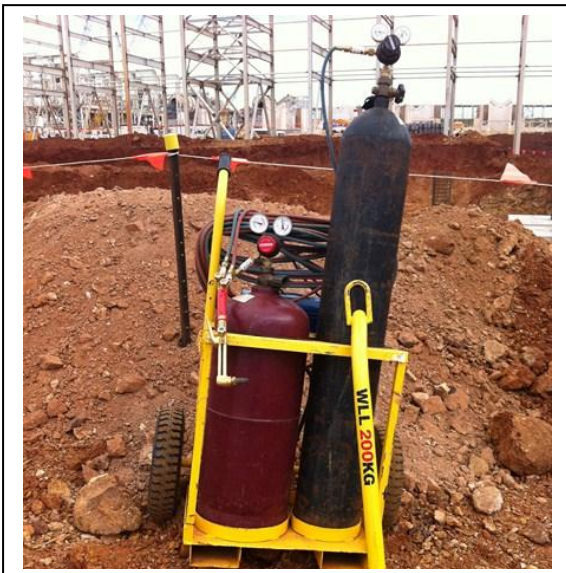
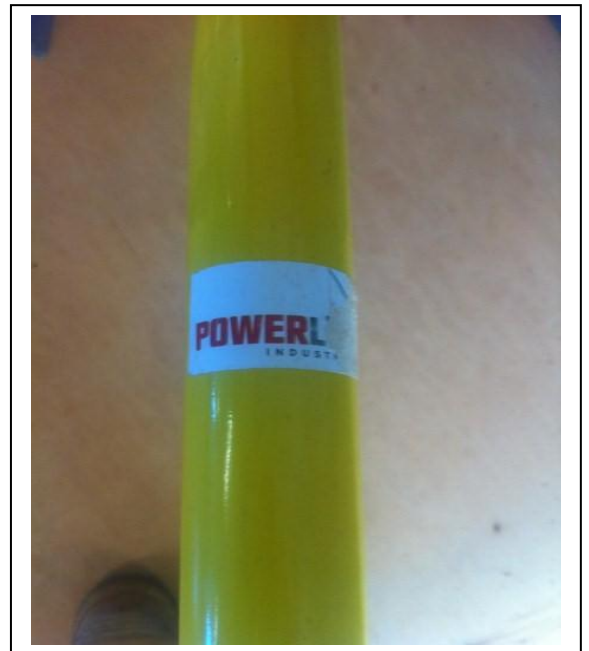
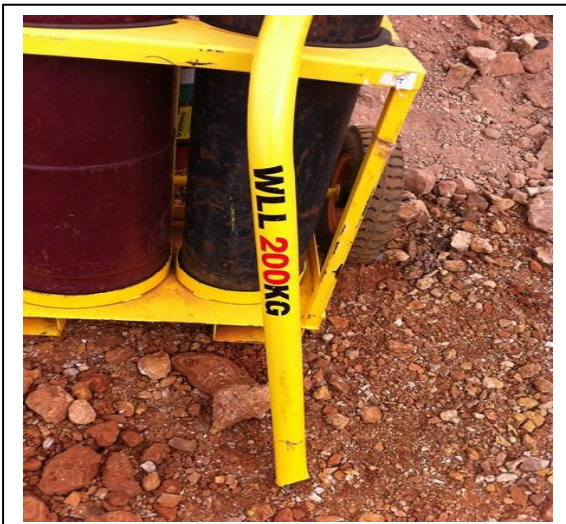
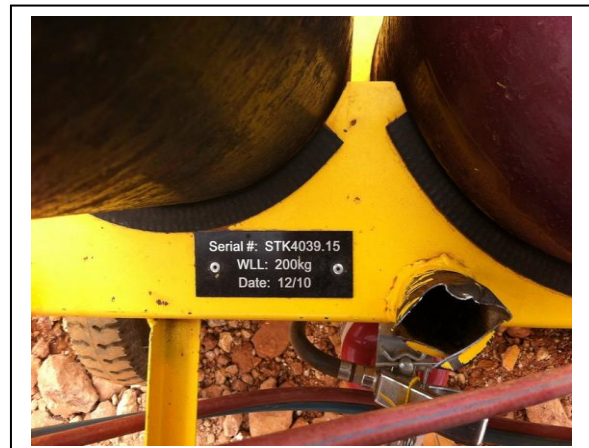
A crane crew has attempted to lift a gas bottle trolley, when the lifting attachment assembly on the trolley has failed. No one was injured but could have had catastrophic consequences. The company that purchased the trolley has begun an investigation into the incident.

1. All lifting attachments on gas bottle trolleys should be inspected regularly for signs of fatigue.
2. Ensure that all trolleys or any other lifting attachments meet AS1418 and come with engineering certificate at point of purchase.
