Safety Alert

Scaffold board failure

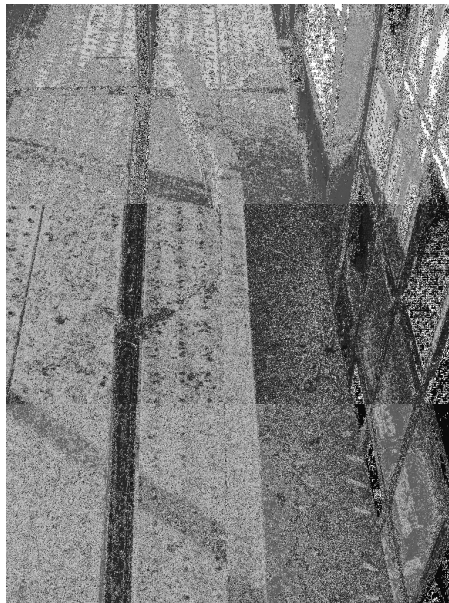
A worker on the top deck of scaffolding at a project in East Perth fell when a plank on which he was standing failed, causing his leg to fall through the scaffold.

The entire scaffold on the project was inspected and approximately 10%-15% of the steel boards were affected by corrosion or other defects. The defective boards were sprayed with fluorescent paint and removed from service by the scaffolders.

Failed steel board

- a) All scaffold boards must comply with Australian Standards 1576 Part 1, AS1577, and AS4576.
- b) Boards should not be used or replaced if they have missing end caps or reinforcing straps.
- c) Boards affected by corrosion, cracked welds, or crushed or damaged sides should not be used or removed from service

The scaffold supplier has been corresponding and co-operating with the union, and has in place procedures which include inspecting and pressure cleaning all steel boards which leave the yard.
